MIKE HUFF & ASSOCIATES

VICTIM BACKGROUND

SCENE INVESTIGATION

SCENE PHOTOGRAPHS

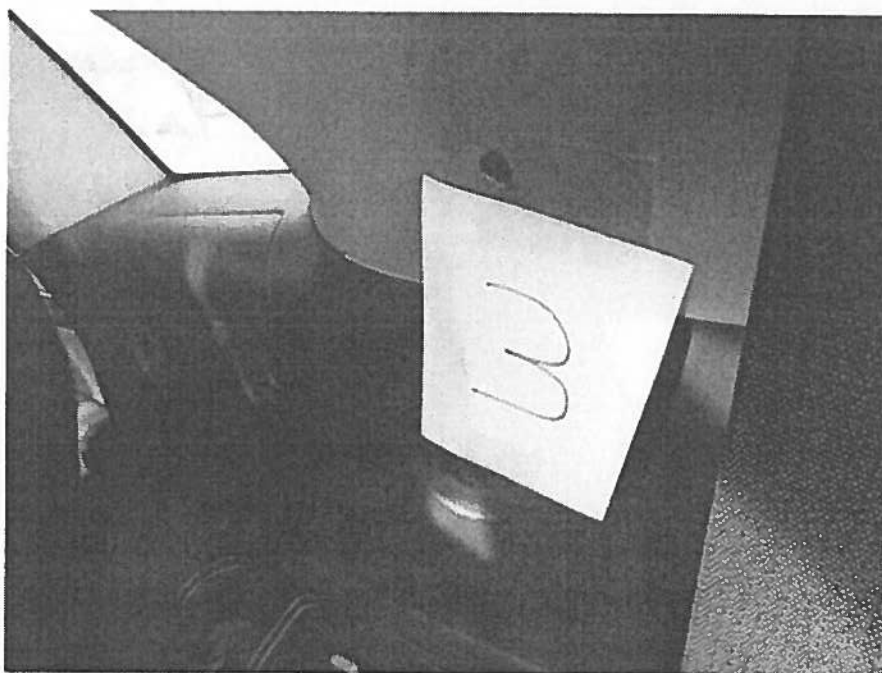
Bullet Strike #3 Was located on the rear passenger side of plastic side panel. This was above the level of the 3rd row seating headrests and seat. There was not an exit. The projectile was not located or recovered by us. Unknown if the OSBI discovered it or recovered projectile. This strike also appeared to be west to east trajectory. This round could only have come from the deputy.

Bullet strike on passenger side interior wall in rear of vehicle. This round was inbound and possibly struck back glass which was shattered. Deputy could be only source for this round.

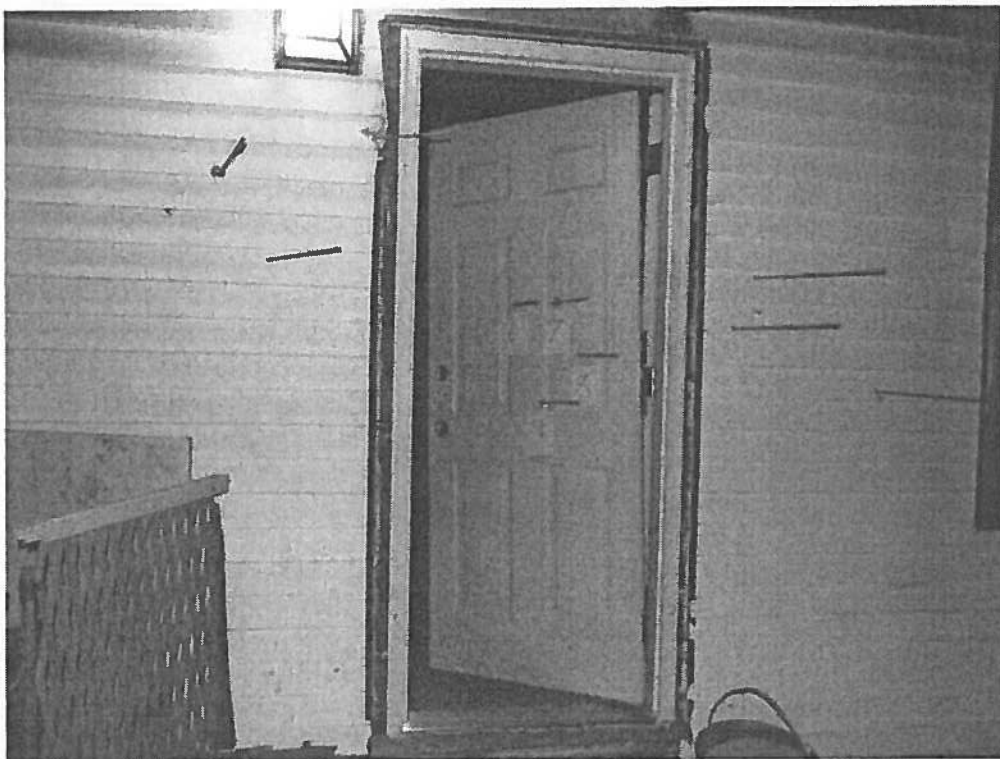
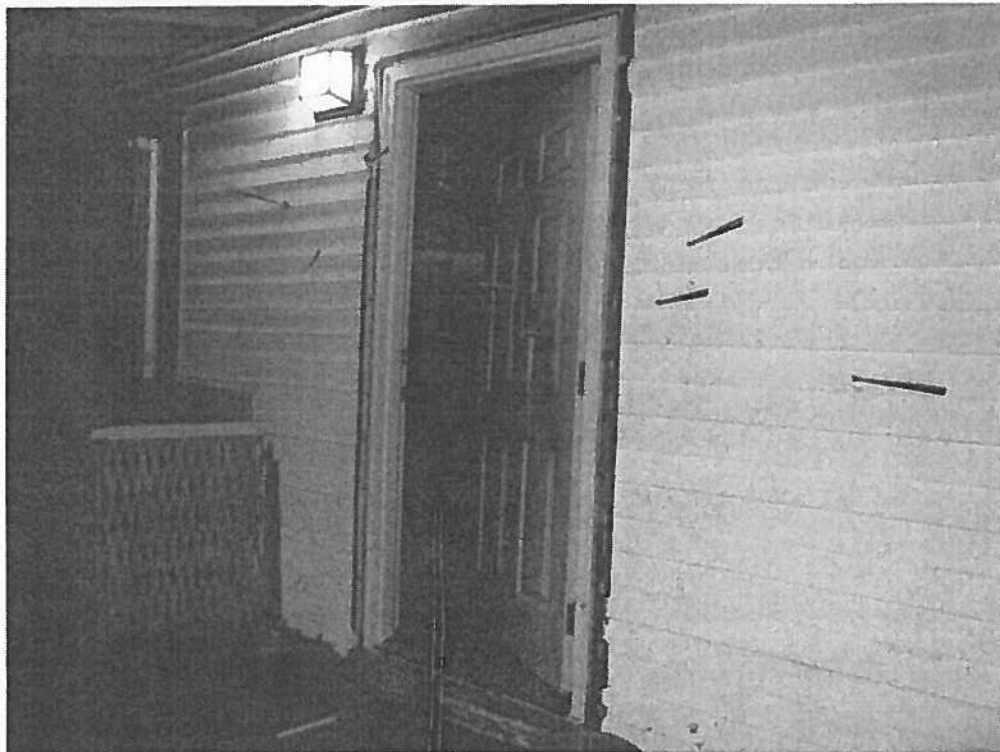
Trajectory
paths
prove
that door
had to be
shut at
the time
of the
shooting.
